Overview of the physical conditions of Voluntary Delivery Stations (PEV) to improve selective collection in Manaus, Amazonas

Vinicius Moura Costa

Valdete dos Santos Araújo

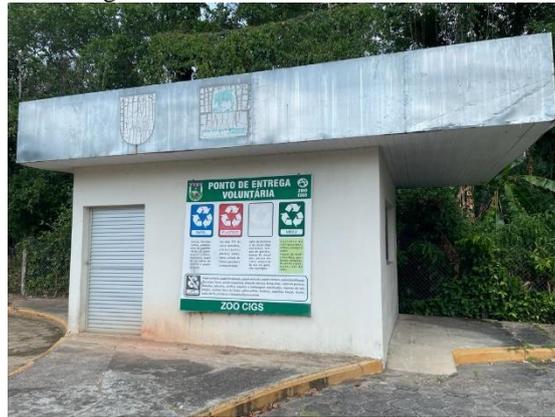
Regarding the abandoned PEVs, only the CIGS collector was found, which does not have the services of the City Hall, as can be seen in Figures 3 and 4.

Figure 3 - PEV abandoned in Manaus.

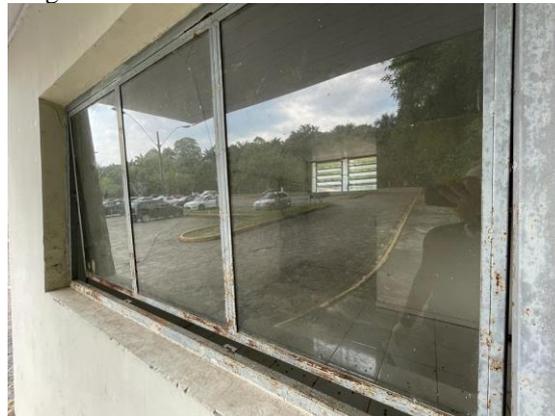
Figure 4 - Interior of abandoned PEV in Manaus.

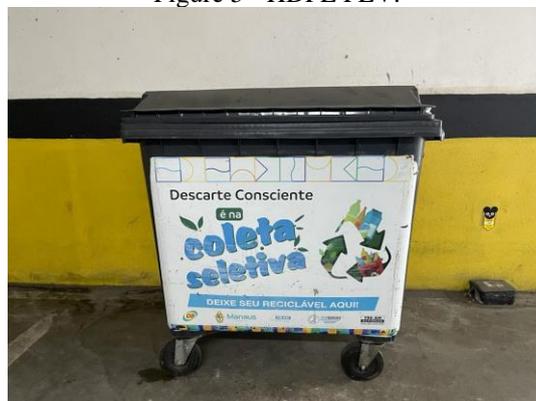
In addition, it is important to analyze which four types of collectors are present in the capital. The most common is HDPE containers (81.8% of PEVs), followed by masonry containers (4.5% of PEVs) and others (13.6% of PEVs), illustrated in Figure 5 to 8.

Figure 5 - HDPE PEV.

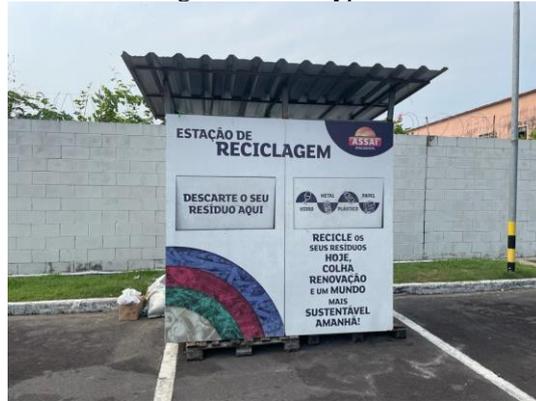
Figure 6 - PEV type 3.

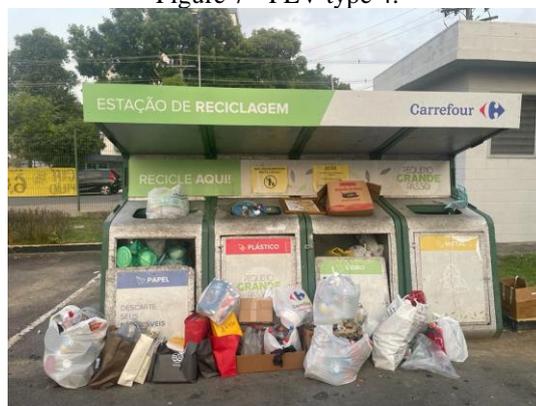
Figure 7 - PEV type 4.

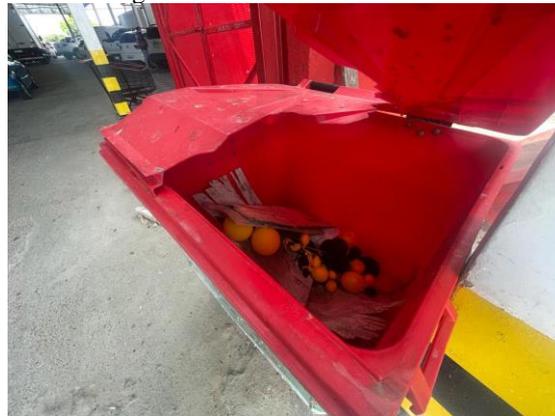
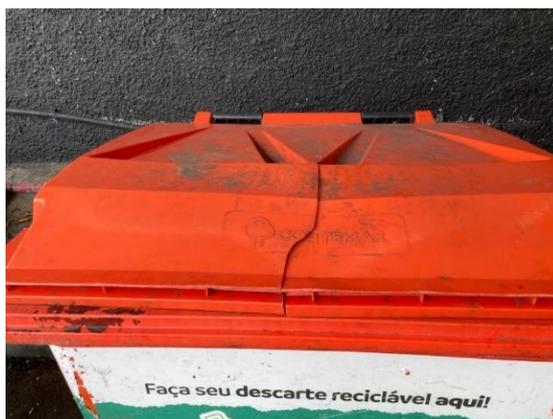
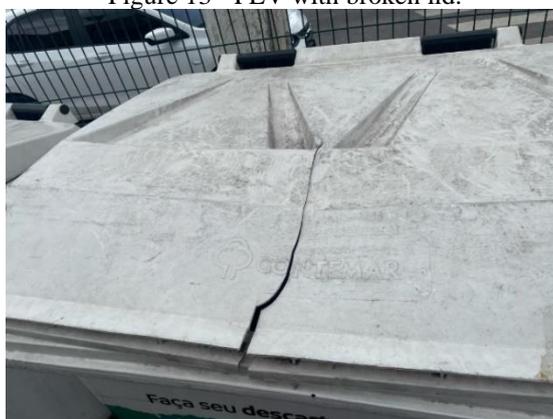
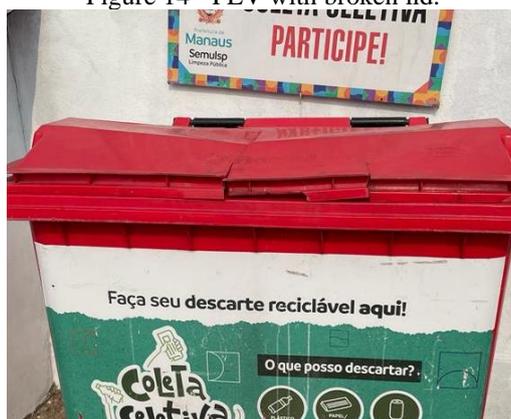
Among the main problems found in the physical integrity of the collectors, there was a large presence of broken lids in HDPE containers, as can be seen in Figure 12 to 15.

Figure 11 - PEV with broken lid.

Figure 12 - PEV with broken lid.

Figure 13 - PEV with broken lid.

Figure 14 - PEV with broken lid.

Finally, the need for maintenance of PEVs in the capital of Amazonas was quantified, where 72.7% of the collectors must have their physical integrity restored, either through the replacement of parts, restoration of identification stickers or others, as shown in Figure 27.

The high rate of collectors with "bad" (40.9%) and "regular" (38.6%) indicators in relation to physical condition, whether due to vandalism and/or lack of maintenance and cleaning, suggests that there should be immediate corrective maintenance, through the Municipal Department of Public Cleaning, in the 32 PEVs indicated in the previous item.

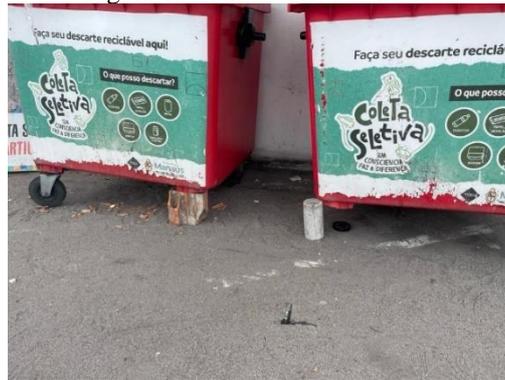
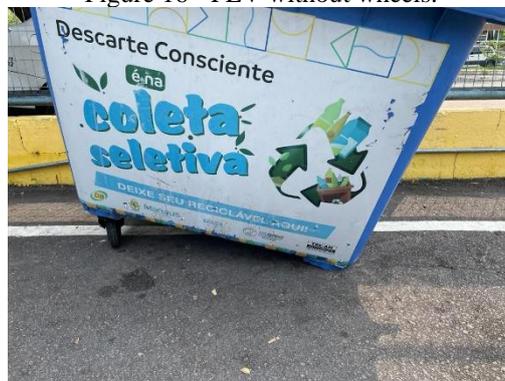
In addition, another anomaly found in the containers was the loss of wheels, which are essential at the time of the collection service carried out by SEMULSP, as indicated by Figures 16 and 17.

Figure 15 - PEV without wheels.

Figure 16 - PEV without wheels.

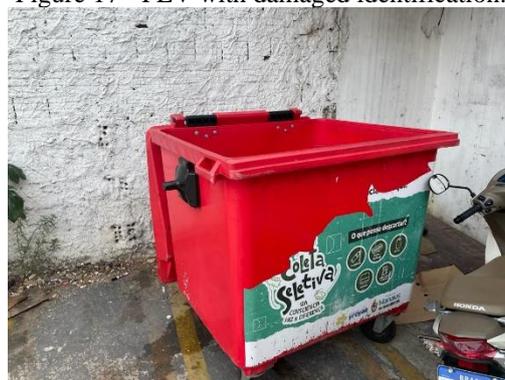
There was also damage to the stickers identifying the selective collection in the PEV, with some of them without any identification, as illustrated in Figures 18 and 19.

Figure 17 - PEV with damaged identification.

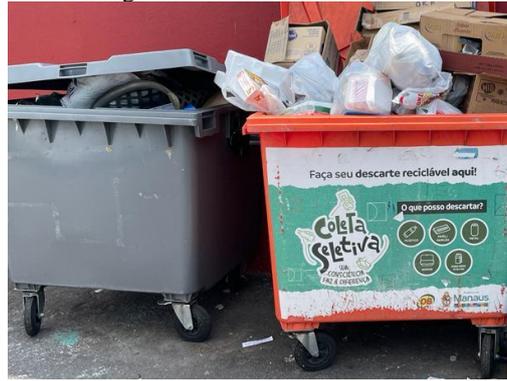
Figure 18 - Unidentified PEV.

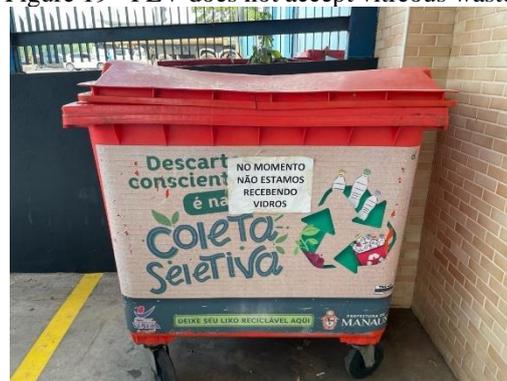
Some PEVs had peculiar information, such as some of them that accepted only some types of inorganic waste, such as "we are not receiving glass" or "only plastic", as can be seen in Figures 20 and 21.

Figure 19 - PEV does not accept vitreous waste.

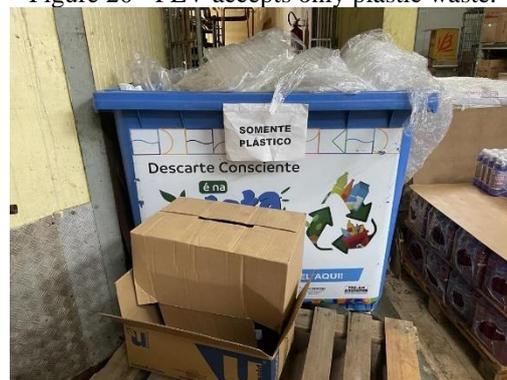
Figure 20 - PEV accepts only plastic waste.

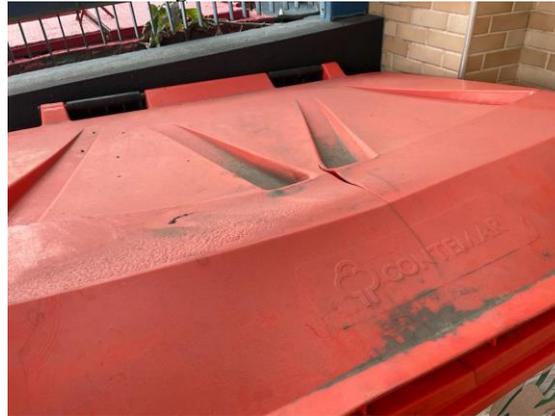
In addition, some PEVs were in need of surface cleaning, as they were covered with dust, especially in the cracks of the lids, as shown in Figure 22.

Figure 21 - Dust in PEV.

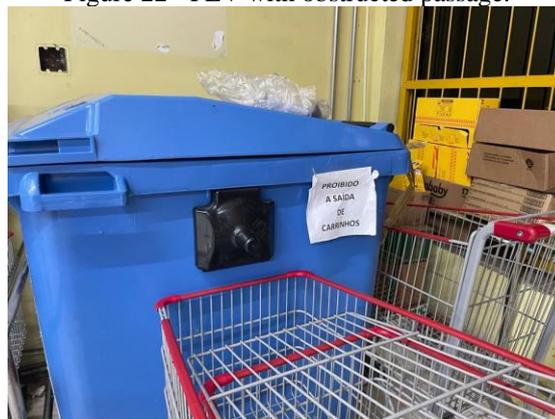
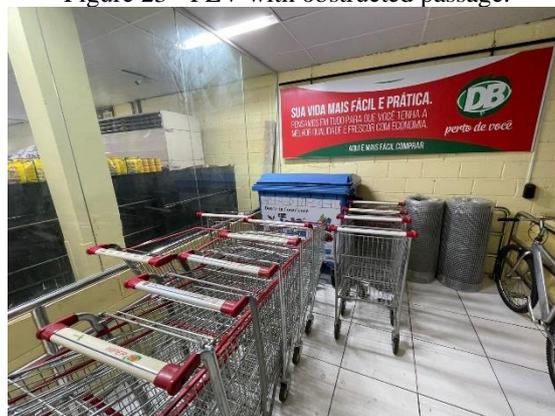
During the research, collectors were also found that had passages with obstacles, more specifically shopping carts. In one of them, there was also a sign on the PEV that read "carts are not allowed to leave", obstructing the passage for the population that wants to carry out the selective collection of their inorganic waste.

Figure 22 - PEV with obstructed passage.

Figure 23 - PEV with obstructed passage.

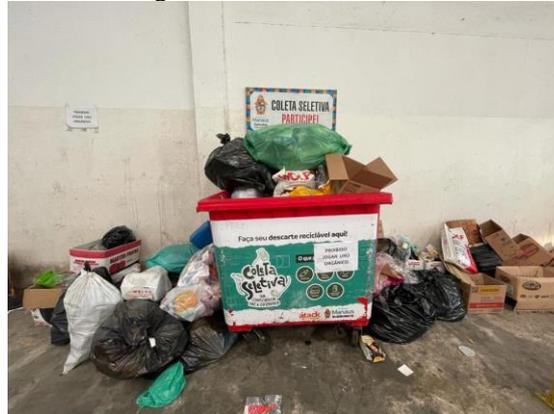
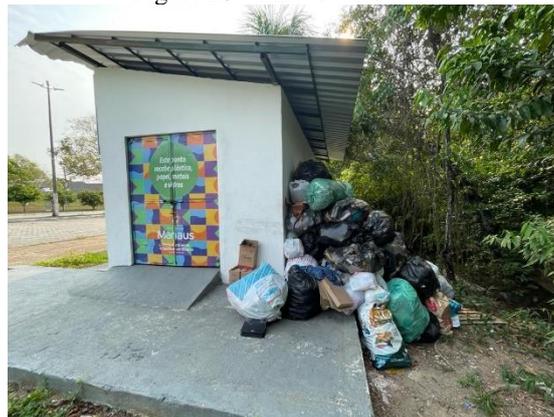
Some of the PEVs were overloaded, which may indicate that there is a need for more collectors in the region or that the collection is not being carried out efficiently, as shown in Figures 25 and 26.

Figure 24 - PEV overloaded.

Figure 25 - PEV overloaded.
